**DEPARTMENT OF TRANSPORTATION****DIVISION OF ENGINEERING SERVICES**

Quality Assurance and Source Inspection

Contract #: 04-0120F4Cty: SF/ALA Rte: 80 PM: 13.2/13.9File #: 69.28**WELDING INSPECTION REPORT****Resident Engineer:**Pursell, Gary**Address:** 333 Burma Road**City:** Oakland, CA 94607**Report No:** WIR-002284**Date Inspected:** 14-May-2008**Project Name:** SAS Superstructure**OSM Arrival Time:** 630**Prime Contractor:** American Bridge/Fluor Enterprises, a JV**OSM Departure Time:** 1530**Contractor:** Zhenhua Port Machinery Company, Ltd (ZPMC), Changxing Island **Location:** Shanghai, China

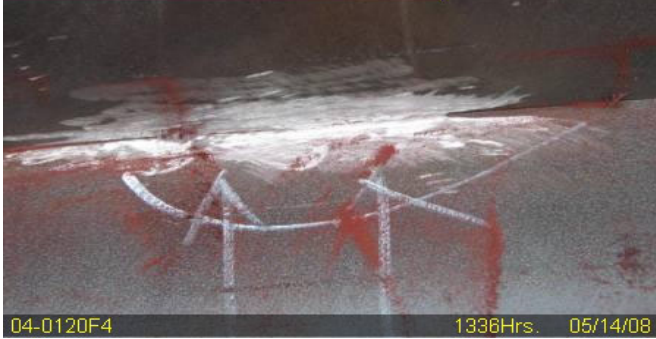
One side panel marked SP096-001-019 was noted with crack on two tack welds. This was discovered by ABF Inspector and this Inspector notified QA Task Leader Dave Mc Clary. ZPMC personnel removed the cracks on

Bay #3: Side Panel SP096-001-019  
2nd tack weld noted with crack. Weld  
removed by grinding then MT'd OK.

two tack welds by grinding off these tack welds. Tack weld removal was then Magnetic Particle Tested (MT) and found acceptable.

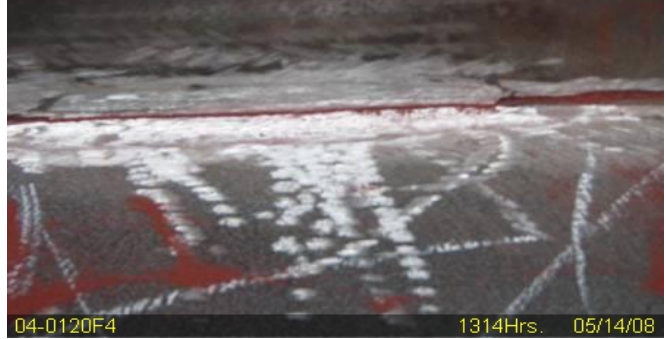
Bay #3: Side Panel SP096-001-019  
Tack weld removed after crack  
was noted then MT'd OK.
